**PORT OF BREMERTON
INVITATION FOR PROPOSAL #03-23-20019**

Port of Bremerton Underwater Inspection of Marine Facilities

Underwater Inspection of Marine Facilities

Prepared by Seattle Diving Services
December 2021

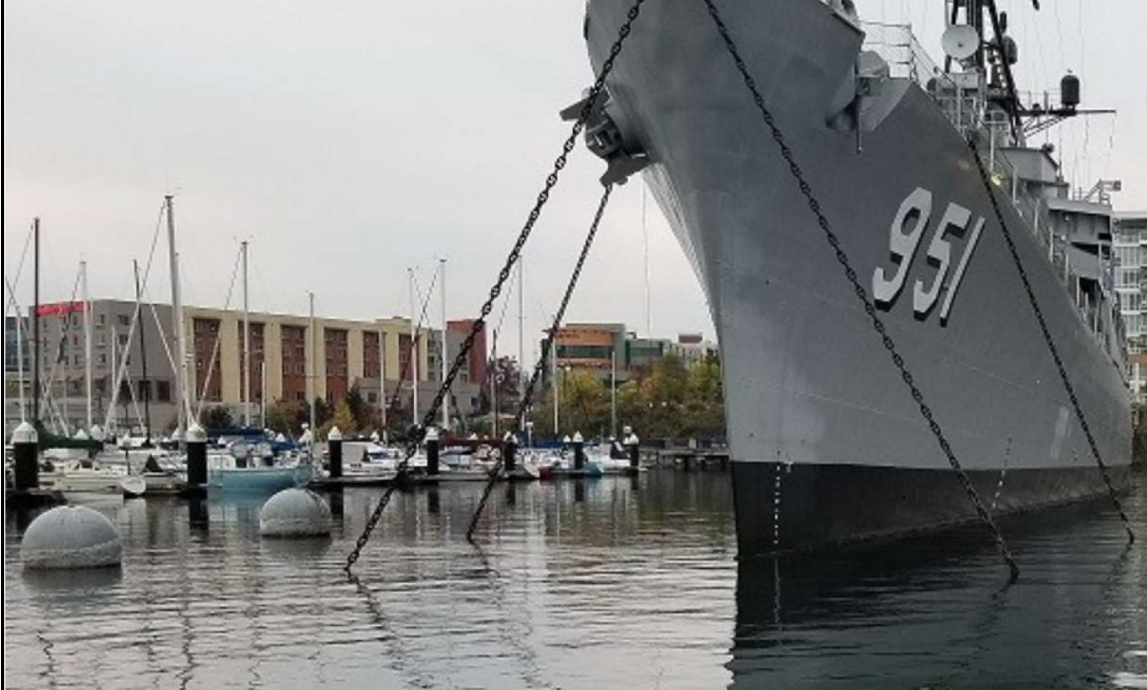
There is one anchor line with a single remaining existing steel buoy supported by an existing 1" chain.
There is one anchor line with no buoy and with loose existing 1" chain underwater.
